**HOUSATONIC RIVER BASIN
TOWN OF AMENIA
DUTCHESS COUNTY, NEW YORK**

**THORNES DAM
NY 00793**

PHASE I INSPECTION REPORT

Thornes Dam (Inventory Number NY 00793).
Housatonic River Basin. Town of Amenia.
Dutchess County, New York. Phase I Inspection
Report.

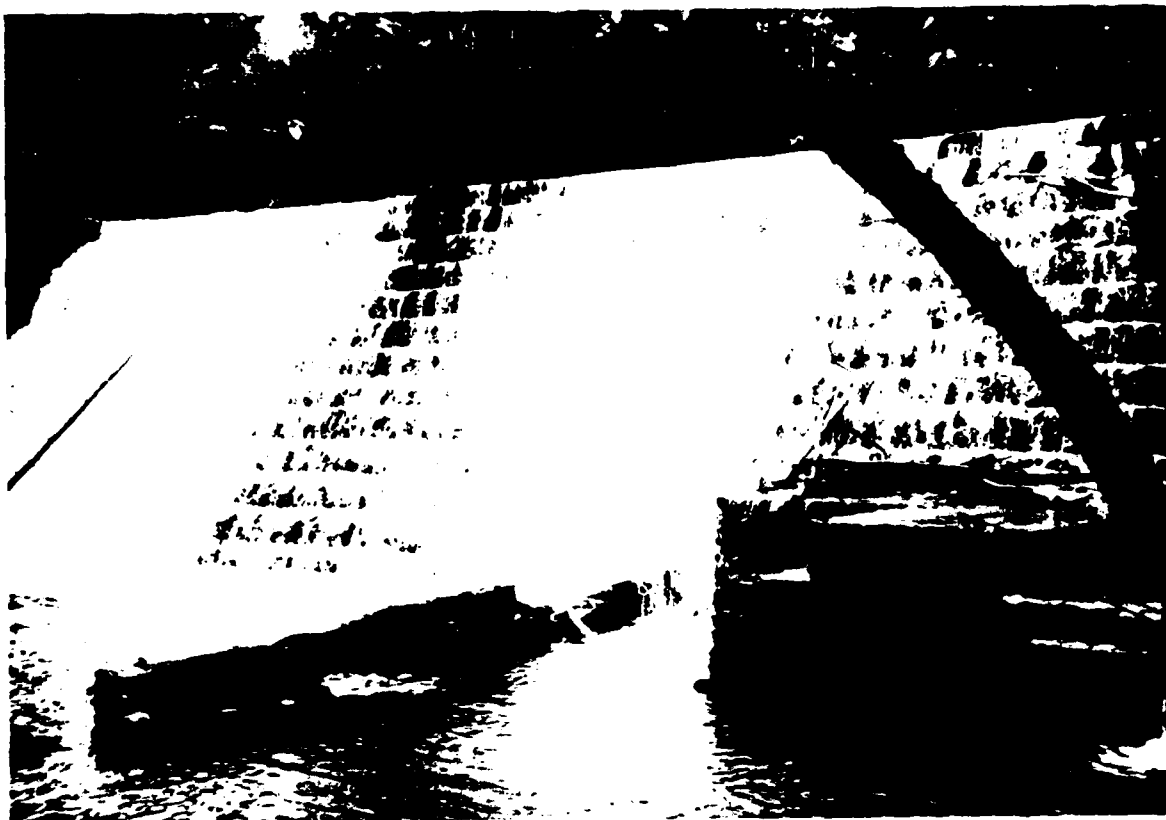
Overview Photo - Thornes Dam - 5/5/81

10 The entire stone masonry dam (see Overview Photo and Photo A-3A) is only in fair condition. The stone masonry of the stepped downstream face shows signs of deterioration due to water action and the weather. Stones are missing and broken; mortar joints are loose with mortar missing in spots; and there is seepage through the joints as mentioned previously (see Photos A-5A, A-5B, and A-6B). The stone masonry in the area of the dam under the spillway section, downstream of the crest, generally appeared to be in somewhat better shape than the downstream areas of the dam near the abutments.

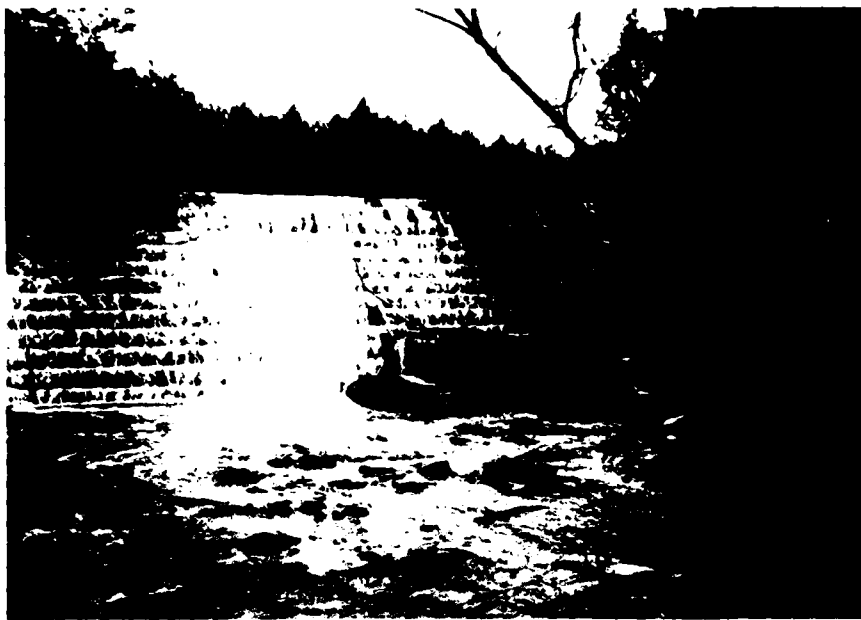
A-3A Downstream side of dam looking from downstream of right abutment - 5/5/81

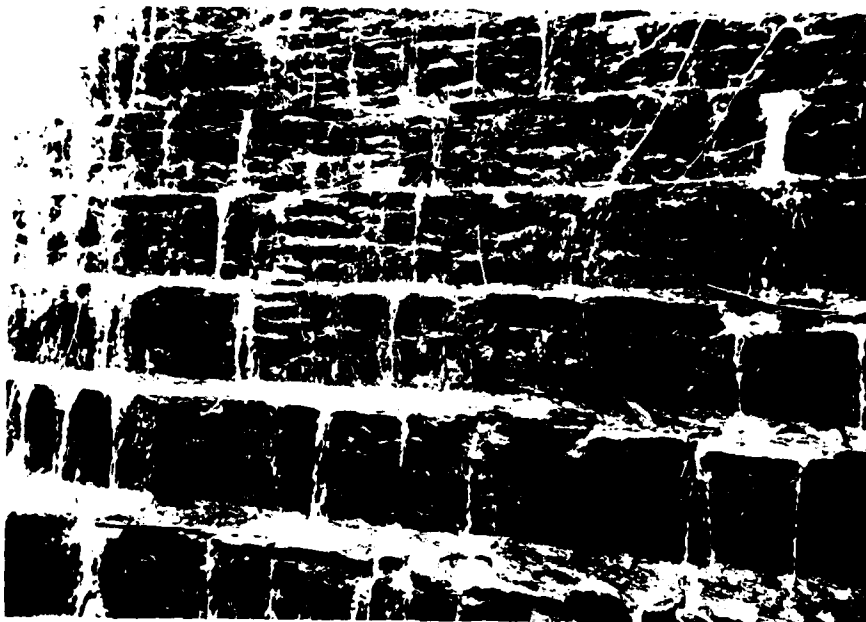
A-5A Typical view of stepped downstream face of dam. Note weathered condition of stones and missing mortar - 5/5/81

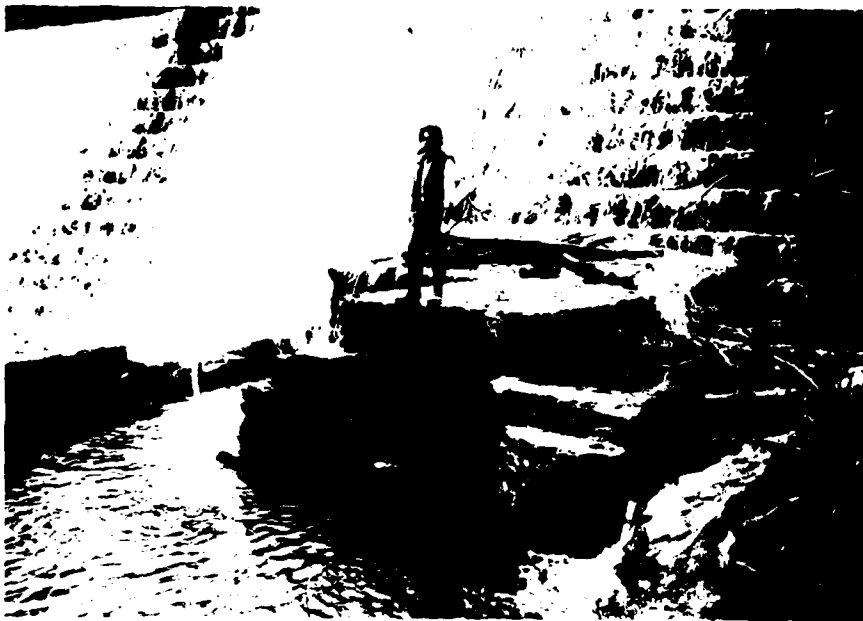
The outlet from the dam is a 48-inch cast iron pipe (see Photo A-8A). The inside of the pipe is rusty but no significant scaling of the iron has occurred. A portion of the pipe about 6 feet long by 2.5 feet wide is missing from the right side, near the gate end (see Photo A-8B).

A-8A Downstream end of outlet pipe - 5/5/81
